Manhole Inspection Summary

Manhole # S51C__016MH

Insp Date: **5/5/08 10:07 AM**

Location Address: **rear 36 n ellwood ave**

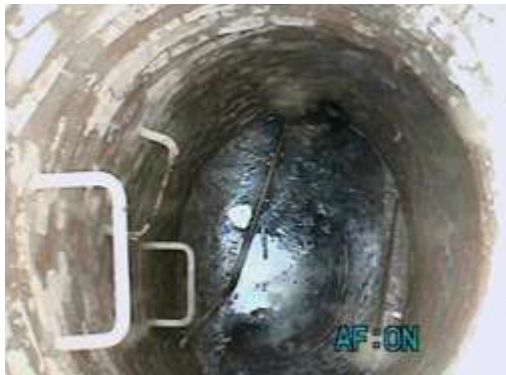
misc

channel debris

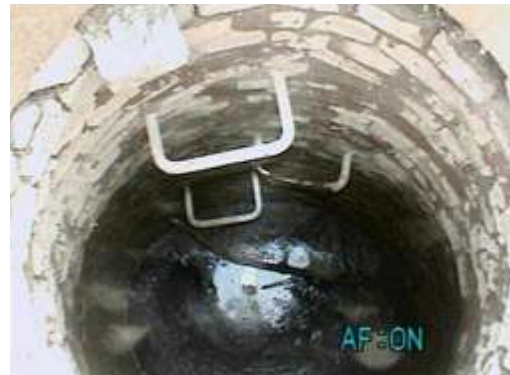
Defect 2

Steps Count: **3** Missing: **1** ☒ **Corroded**

steps

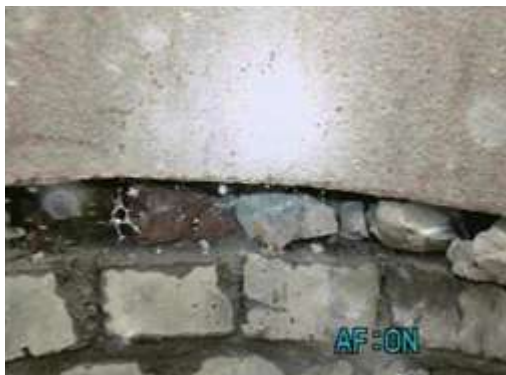
Defect 1

Condition: ☐ Sound ☐ Cracked ☐ Root Intrusion ☒ **Loose Brick** ☒ **Deteriorated**

deteriorated, loose bricks @ frame adjustment

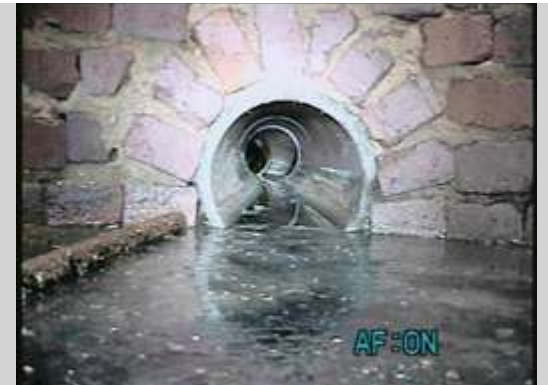
12 O'Clock Outflow

8 in. Circular Gravity Sewer
Pipe Out @ 12 O'Clock
